# Ballistic Perforation of Graphite/Epoxy Composite

December 1996

# Special Report 96-29

## **Ballistic Perforation of Graphite/Epoxy Composite**

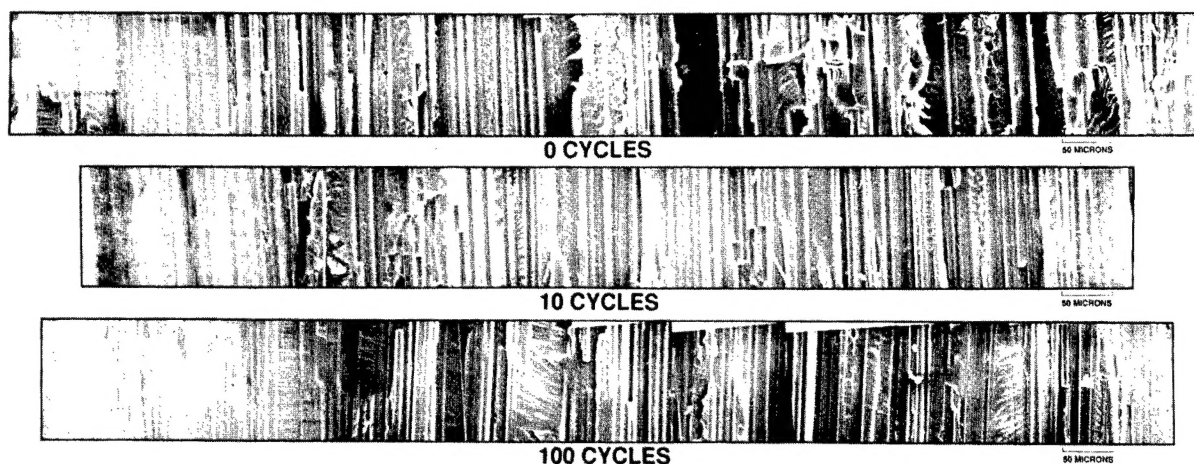
The hackle marks present a periodic formation of sigmoidally shaped ridges and troughs running roughly parallel to the fiber direction and located in the matrix region between them. There is a spatial periodicity perpendicular to the direction of the fibers, which is the first suggestive observation. The second observation is that the wavelength of these hackle marks appears to increase as the distance between the neighboring fibers increase (Fig. 7a). The wavelength of the hackle mark is of the order of the order of interfiber distance. Sometimes, the ridges appear to be canted at an angle to the fiber axis.

Figure 8. Scanning electron micrographs of a 7-ply AS-4/3501 laminate transverse fracture surface from static tension test after low temperature thermal cycling (Dutta and Taylor 1989).
